HARDWARE GUIDES

Maintenance guide for EuroProt+ devices

DOCUMENT ID: PP-13-226045
VERSION: 2.0
2022-11-18, BUDAPEST

PROTECTION, AUTOMATION AND
CONTROL FOR POWER INDUSTRY

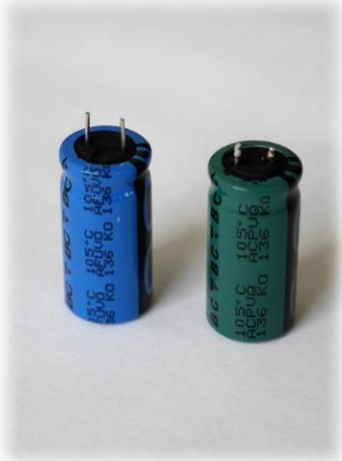
Figure 4-1 The capacitor on the right is already discolored

Power supplies are designed with the longest possible life electrolytic capacitors. Their expected lifetime depends significantly on the environmental conditions of the device. During a scheduled inspection, we recommend visual inspection of the power supply for any abnormalities in the capacitors. The most common phenomena are: bloating, electrolyte leakage, discoloration, which typically occurs on capacitors, but can also occur on the surface of the PCB board due to leakage. In case of abnormality, the capacitors should be replaced. In such a case, please contact Protecta's Application Department via our support page (<https://support.protecta.hu/>)!
